Manhole Inspection Summary

Manhole # S2901_013MH

Insp Date: **2/26/08 8:57 AM**

Location Address: **2819 Bookert Dr**

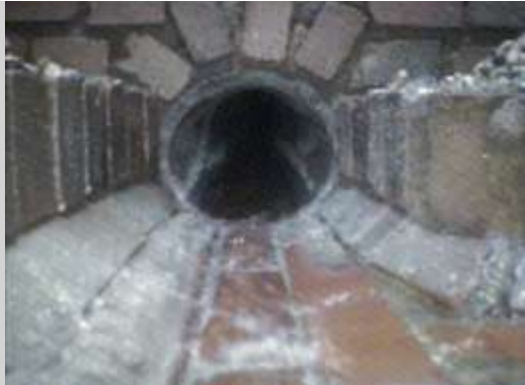
12 O'Clock Outflow

8 in. Circular Gravity Sewer
Pipe Out @ 12 O'Clock

Pipe Height: **10.8** (in.) Rod and Bar (Angled)
Pipe Material: **Clay** ☐ Pipe Lined
Invert Depth: **9.08** (ft.) Flow Characteristics: **Fast**
Deposits: ☒ None ☐ Mud ☐ Sludge ☐ Debris ☐ Grease
Silt Depth: (in.) Deposits Extent:
Infiltration: **None** Pipe Seal Cond: **Sound**

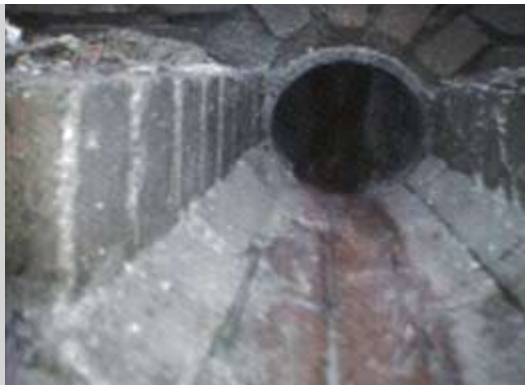
3 O'Clock Inflow

8 in. Circular Service Sewer
Pipe In @ 3 O'Clock

Pipe Height: **7.2** (in.) Rod and Bar (Angled)
Pipe Material: **Clay** ☐ Pipe Lined
Invert Depth: **8.90** (ft.) Flow Characteristics: **Fast**
Deposits: ☒ None ☐ Mud ☐ Sludge ☐ Debris ☐ Grease
Silt Depth: (in.) Deposits Extent:
Infiltration: **None** Pipe Seal Cond: **Sound**

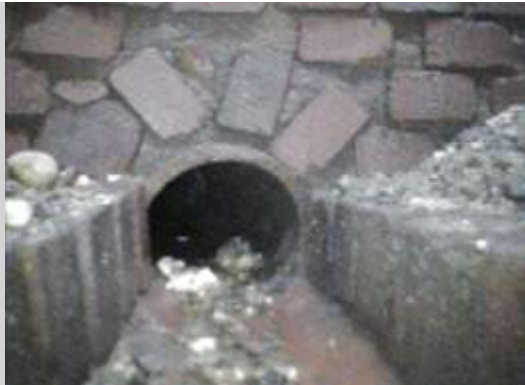
6 O'Clock Inflow

8 in. Circular Gravity Sewer
Pipe In @ 6 O'Clock

Pipe Height: **8.4** (in.) Rod and Bar (Angled)

Infiltration: **None** Pipe Seal Cond: **Sound**
